METHOD TO ANALYSE THE FAILURE PROCESS OF METAL-POLYMER IMPLANTS BY 3D SCANNING

István Nemes-Károly¹, Gábor Szabényi^{1,2}

¹ Department of Polymer Engineering, Faculty of Mechanical Engineering, Budapest University of Technology and Economics

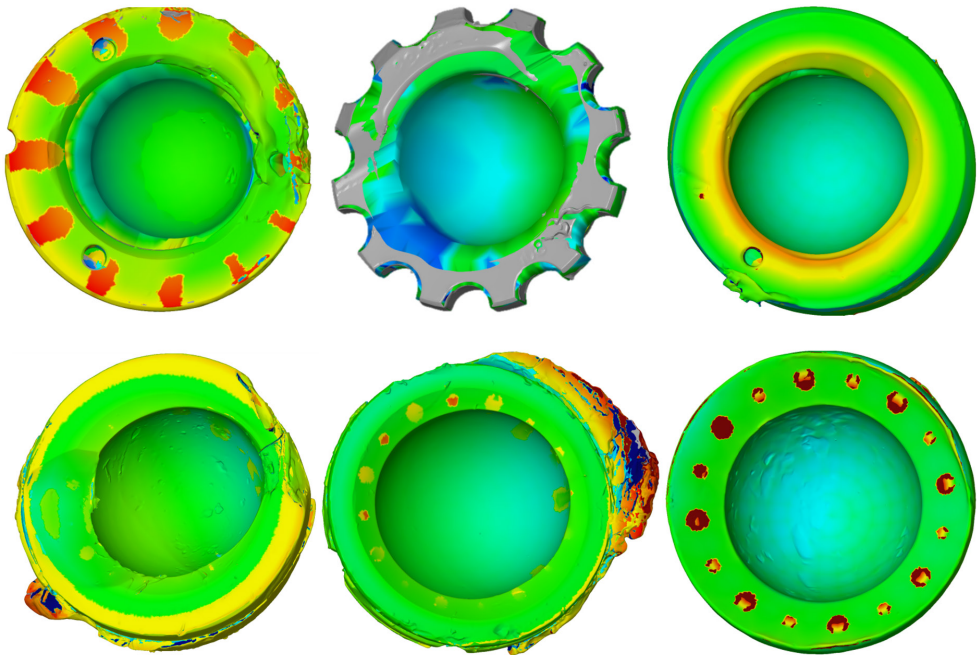
In the case of implants without cement fixation – Figure 5 top line – it can be noted that the first and third samples are of an older type, but the middle one is a modern prosthesis.

The first implant can be said to have worn along a band during wear, so a stripe can be seen in the images. The spherical part of the cup, which came into contact with the head, became ellipsoidal, the major axis of which is the previously mentioned band. Point corrosion, scratches, and abrasions can be observed

on the surface. The edges of the right-hand cup were wrinkled – also along a band – due to deformations. Abrasions and scratches could also be observed on its surface. However, these changes are perhaps not as conspicuous as the change in the middle workpiece, which is strange since it seemed the youngest of the three prostheses based on its design.

In the case of cement-fixed implants – *Figure 5* lower line – the difficult-to-remove bone cement caused some problems during the meas-

Figure 5. Scanned hip joint implant sockets (upper row – cementless, lower row – cemented sockets)

In the figures, the elliptical shape of the spherical part of the tufts can be observed with a simple eye measure without taking colouring into account. It was also visible that the rate of uneven wear was also much higher than that of their cementless counterparts.

Also, with these implants, it can be seen that there is a privileged direction in which the head begins to wear out the cup. In the first two cases this is well visible but even in the third, it can be seen, although it presumably spent a much shorter time in regular use. This can be explained by the fact that the material loss found on it is much less than that of other cement-fixed ones. Still, on its surface, a significant amount of craters, abrasive debris, and abrasions can be observed in the pitting pattern. At the same time, relatively large pieces also detached from the cup, leading to implant loosening and premature revision.

Similar surface damage was observed on the first implant, but there the surgeon performing the primary operation fixed the prosthesis into the pelvis in the wrong position, so the femoral neck of the prosthesis touched the cup, creating a depression on the left side of the part of the implant. Damage to this prosthesis (Figure 7) suggests that this may have inhibited the patient's movement, as otherwise, such damage on the cup would not have occurred. This could have caused several problems and symptoms while wearing it.

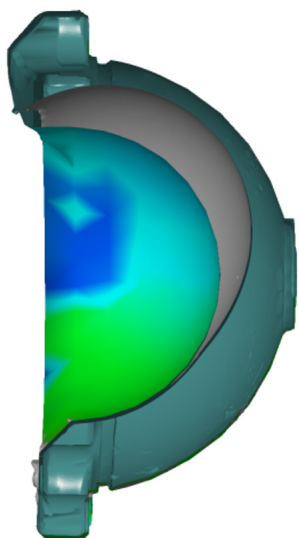
The middle (upper) sample shows that the head began to deepen the ravine around a point, and this process was already very advanced (*Figure 6*). On the opposite side, however, the material was practically not consumed, so there was no stress on the part at that location. At this certain critical point the material thinned so much that, if the implant was kept in intense light, it was almost transparent. The shadows on the other side were already visible, so this clearly had to be replaced during revision surgery.

ous than that of the other two implants, as here the loads and abrasive effects are concentrated at and around the critical point, but the only abrasion was observed on the work surface.

The approximate original wall thickness is shown at the below part of the cross-sectional figure in *Figure 6*, where the point cloud and the geometry of the CAD model are presented together in overlay. On the other hand, as we look upwards, these two surfaces become more and more distant from each other. The change can also be traced in the colouring, the almost perfect fit is green, while in the upper section, it is getting darker blue with a marked dark blue spot between the blue and green gradients, probably representing damage created during resection.

Figure 6. Cross-sectional 3D scan view of the second investigated cementless (Figure 5 upper row, middle) hip joint socket

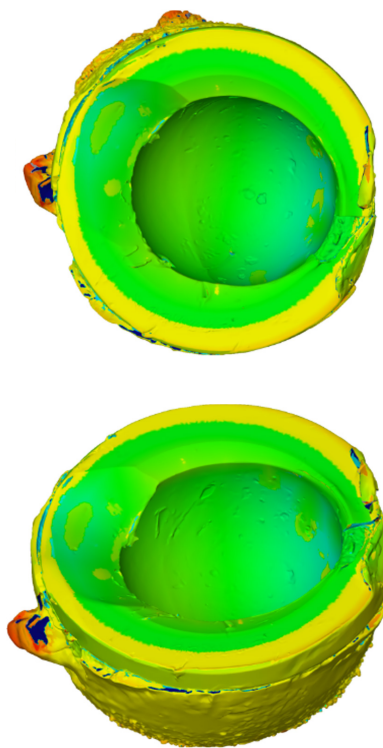
Implantation of the second prosthesis was appropriate. Even so, its distortion is comparable to that of the first. The recess on the right side is also shown to be blue on the colour scale (Figure 7), and it can be seen with the naked

Figure 7. 3D scan of an incorrectly implanted socket

eye that its shape has changed to an oval shape during use. On the other hand, the inner surface of this - in contact with the head of an artificial joint - is relatively even. There are no grooves, scratches, or other signs of damage.

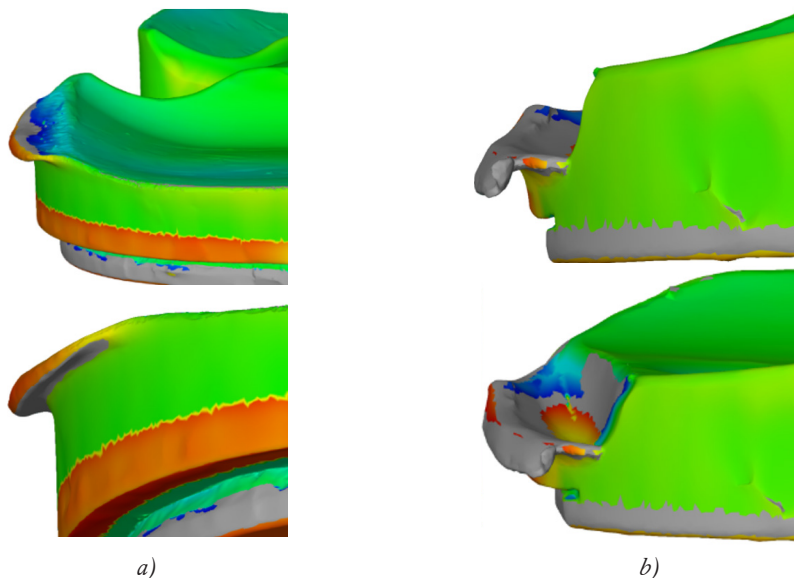
Examining the first prosthesis, the middle and back sections were damaged and, not signifi-

Figure 9. Investigated right back edge of the first investigated sample
a) left edge of the second investigated sample; b) tie-shaped deformation

cantly, obliquely, with scratches and abrasions, and a phenomenon known in the literature as a bow tie, a bow-tie sign (*Figure 9*).

This can also be observed on the right side of the middle sample. However, two recesses can be seen in the central area of the implant – with pitting, abrasion, and scratches around them – it does not appear so markedly here that the wear in the posterior regions is almost the same as in the middle. It can be said that the structure operated at least one-sided, as the deformation on the right side is more extensive, but this is not as significant as in the case of uni knee implants.
