METHOD TO ANALYSE THE FAILURE PROCESS OF METAL-POLYMER IMPLANTS BY 3D SCANNING

István Nemes-Károly¹, Gábor Szabényi^{1,2}

¹ Department of Polymer Engineering, Faculty of Mechanical Engineering, Budapest University of Technology and Economics

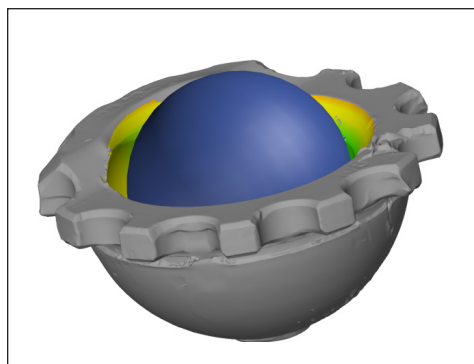
Figure 4. Definition of a sphere into the 3D scanned socket

The warm colours displayed by the software in the figures show deviations from the reference surface in a positive direction, which means that the surface element under examination exceeds the reference. Cold colours have just the opposite meaning, so the deviation is in a negative direction, which means that the surface under study is under the reference surface. The green colour indicates the perfect fit. The method of the description given by us can only be interpreted on the surface of bodies and this is also given for the sake of illustration, not as an exact definition. The more intense the colour, the greater the deviance. The scale can be adjusted appropriately to the differences in the examined implant in the program.
